**Hoe kom je aan goede  
ongevalsinformatie?**

**Hoe kun je ongevalsinformatie  
goed analyseren?**

**Achilles**

**FACTS #21437**

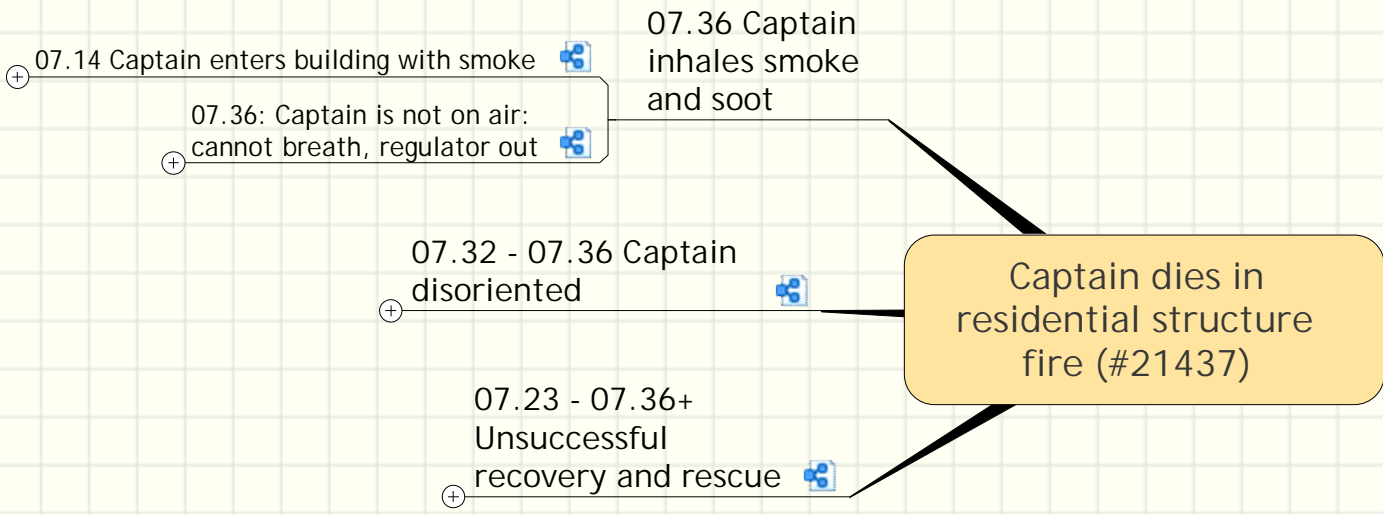
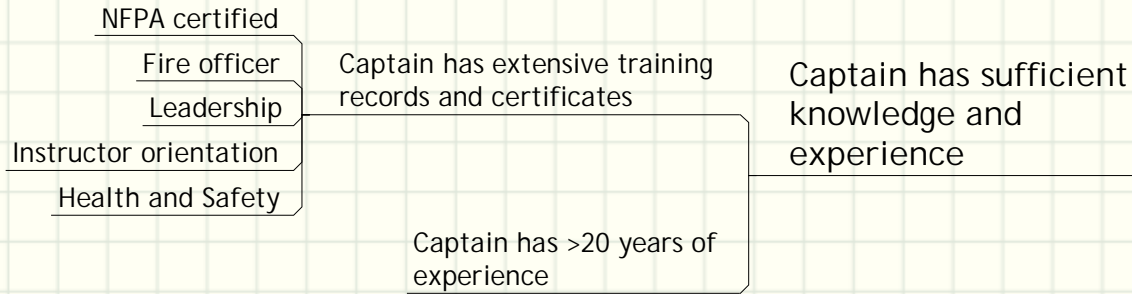
**ACHILLES #21437**

Fire fighting team absolutely unaware of source, location and spread of smoke

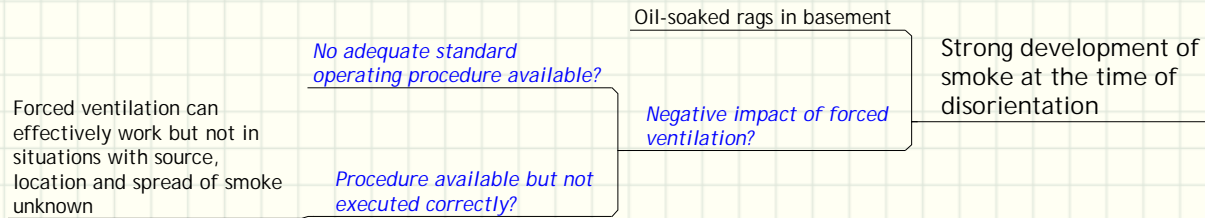
07.14 - 07.36 Captain does not take precautions on missing knowledge of the source, location and spreading of smoke and fire

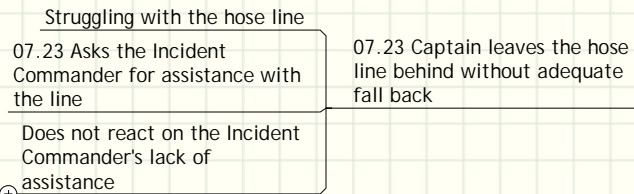
0732 - 07.36 Captain does not respond adequately after calling for assistance, being lost with Fire Fighter #2 at 2nd floor

07.36 At the time of Mayday, recovery is physically impossible

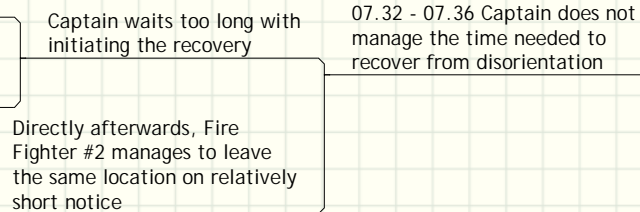
07.32 - 07.36  
Captain disoriented
